Survey of Some High-Risk Erosion Sites in Kogi State, North-Central Nigeria using Remote Sensing Techniques

Satellite images (Landsat 2001) for four local government areas of Kogi State, including Ankpa, Dekina, Okene, and Kabba-Bunu, were used for the survey of nine (9) high-risk erosion sites. This was done to determine the spread, development, and dynamic of gullies in the areas. Gully borderlines were delineated for the identified gully system in each of the local government areas. Gully parameters such as length, width, and depth were determined. The gully was classified into severe, moderate, and mild. The result shows Ankpa and Dekina with the longest gully length ranging from 300m in Ajobe to 700m in Ogane Aji-Dekina with 7m to 25m width and a depth of about 4m to 7m. Moderate gulling was apparent in Omigbo Kabba water channelization with a gully length of 500m, 15 meters width, and 4 meters depth, followed by Etahi and Agassa in Okene Local Government Area. Mild gullying with a total gully length of about 1.2 meters in Etahi and 1.4 meters in Agassa. The recorded width ranges from 20 to 25 meters with 17 meters depth in Etahi to 4 meters in Agassa.

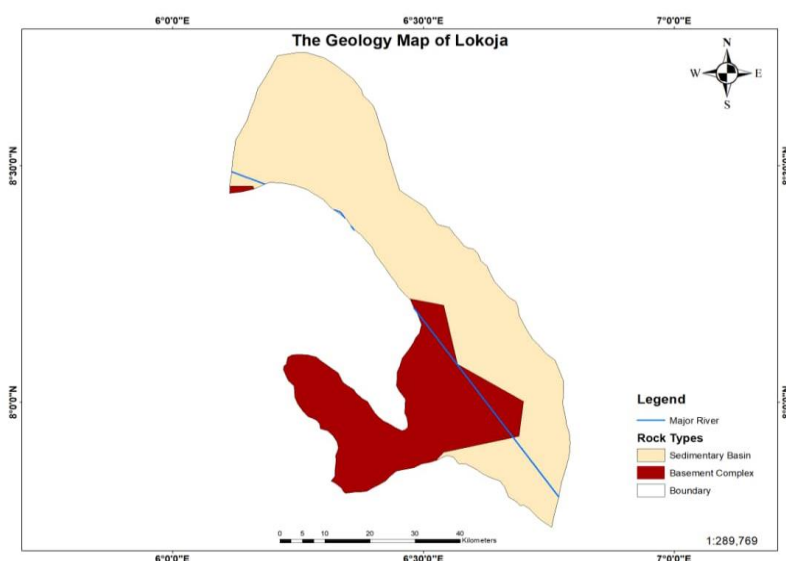
Fig. 1: Geology of Lokoja

The western part of the state, colored red in Fig. 1, comprises basically the basement complex; they are made up of migmatite and gneisses. The schist belts (metasedimentary and meta-volcanic rocks) KSMSMD (2014). Omali (2014) described the geology of Lokoja to be bounded to the south and the west by the migmatite gneiss complex of the Kabba – Okene area and on the north and the eastern part by the cretaceous sedimentary rocks of the mid-Niger basement, which overlies the basement complex rock. The eastern part of the state is on the alluvial (youngest and most recent sedimentary rocks); these areas lie within the Anambra basin.

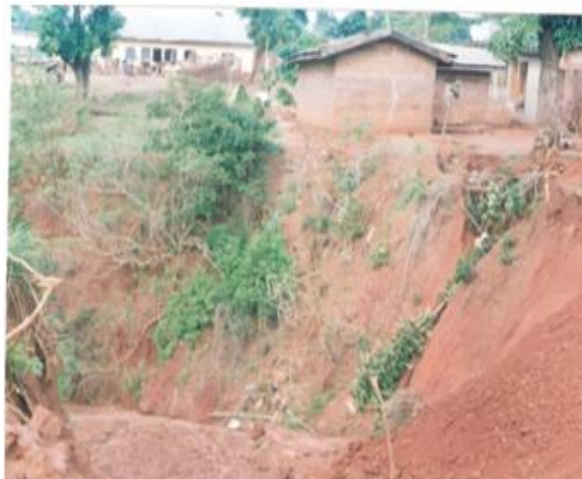
Ankpa (Ajobe) Gully (Plate 1)

i. Ajobe in Ankpa falls within the humid tropical rain forest belt of Nigeria with an annual rainfall of about 200mm; the vegetation falls within the guinea savannah belt. It consists of lowlands and hills with an average elevation of 900ft. The gully has a dimension of 300m long, 7m wide, and a depth of 4 m, causing massive destruction of houses and properties; these represent the longest gully length within the Ankpa Local Government Area (Plate 1).

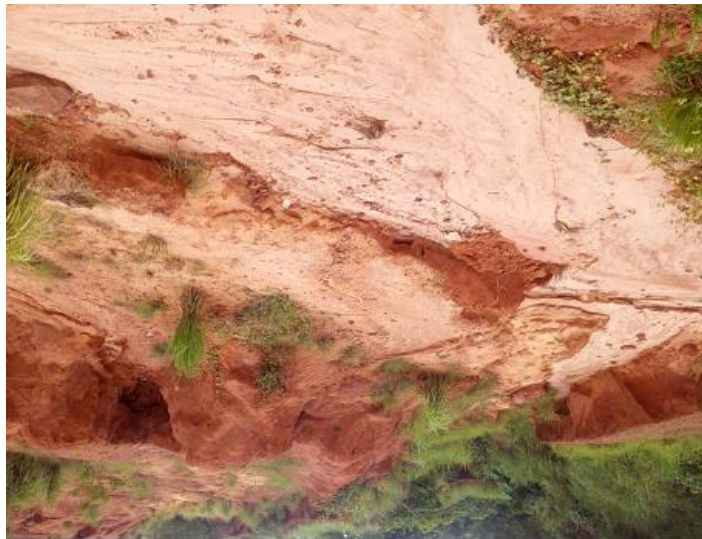
Okura Gully (Plate 2)

- i. Ogane Aji (Anyigba): This area is located within Anyigba town, a few meters from CMML Secondary School. During site visitation, the gully site was measured to have a gully length of 700m, a width of 25 m, and a depth of 7m. The site has a slope in front of Idrinana hotels and some residential houses all round the gully. It is the longest and the deepest within the study area.
- ii. Atanigoma—This site is located along the Atanigoma area in Anyigba. It has a length of 300m, a width of 2 m, and a depth of 1m; it is suspected to have occurred from uncontrolled run-off along the highway.
- iii. Okura – This site is located near the major highway, measuring 110m long, 15m in width, and 2m deep. It has no vegetation cover and therefore allows for detachment of soil and enhances easy run-off.

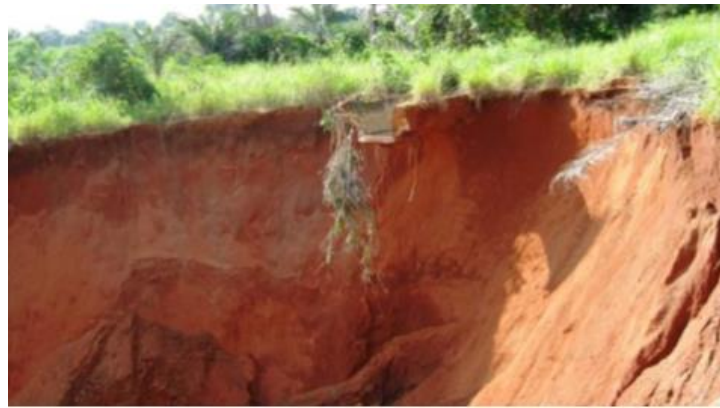
**Okene Gully (Plate 3)****Table 3: Gully Site in Okene LGA**

- i. Etahi – This site measures a gully length of 1.2m, a width of 25 m, and a depth of 17 m. Land use affected includes pathways and residential buildings. The erosion was suspected to have occurred from uncontrolled runoff.
- ii. Agassa – This site is located in Agassa near GRA and Agassa Secondary School. The site was measured to have a gully length of 1.4m, a width of 20 m, and a depth of 4m. The topography of the area is slightly undulating.

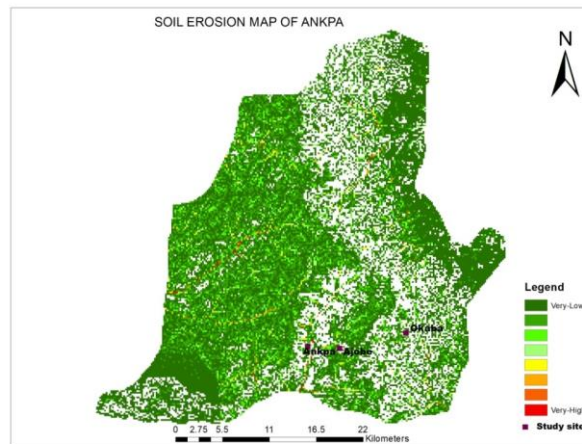
Fig. 3: Soil Erosion Map of Ankpa

Table: 1,2,3 and 4 represent major gully sites within Ankpa, Dekina, Okene, and Kabba-Bunu Local Government Areas. The inherent characteristics of the local soil to a large extent promote the spread of gully erosion. Anthropogenic factors with regards to land use, afforestation, poor drainage systems, and bad farming practices have all contributed to gully development (Chisci, 1981; Oformata, 1987). From the overall analysis, Ankpa and Dekina Local Government Areas, which form part of the loose unconsolidated soil of the Anambra basin (Murat R.A., 1972), are the most affected by gullies, particularly in terms of magnitude or severity of occurrence in Kogi State. With Omigbo in Kabba, water channelization moderately gullied, and lastly, Okene LGA territory mildly gullied. Figs. 3-6 represent various gully maps of the respective LGAs, with the red colour indicating high-risk gully areas.
